Historic Building Record:  
No.8 Olney Road, Lavendon  
Olney MK46 4EU  
(NGR 491625, 253553)

Planning Application Ref. 14/00093/FUL

Milton Keynes HER Event No. EMK1259

SOUTERRAIN PROJECT SOU15-397

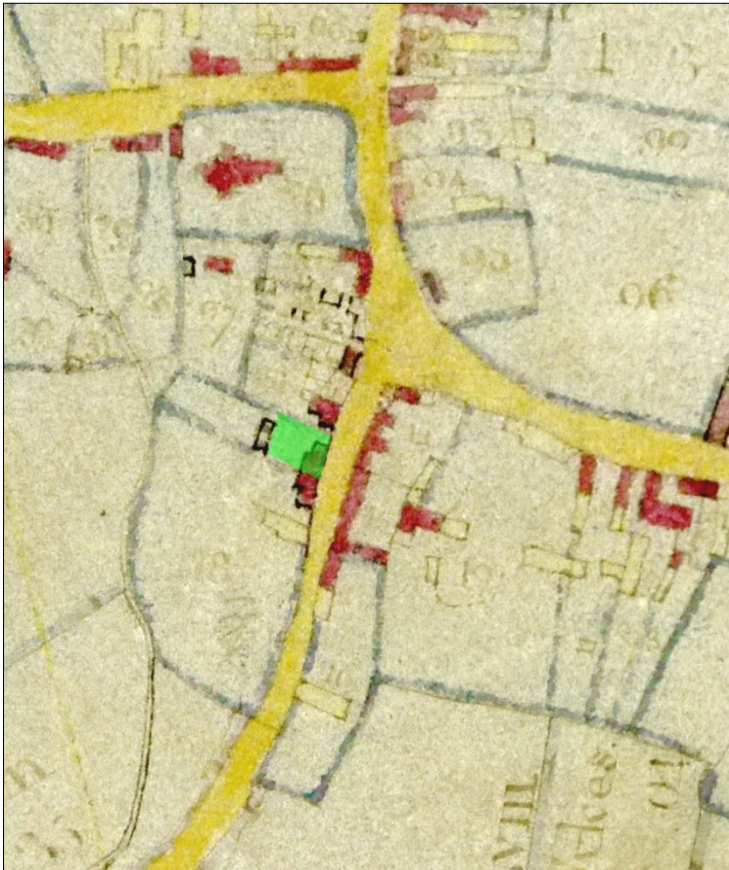
**Figure.2**  
**Extract of 1801 Lavendon Inclosure**  
**Award Map.** Area of proposed  
development highlighted in green

- 4.1 The earliest known map of the site on which the property stands is that surveyed for Lavendon's Inclosure award of 1801<sup>4</sup>. An extract of the map is shown at Figure 2 with the proposed development area highlighted in green. The map was prepared on parchment at a scale of 6 chains to the inch. It is has faded with age and suffered distortion. The survey was probably carried out by using a Gunter chain and is reasonably reliable for comparative purposes, although not for overlay of the map with later Ordnance Survey 2500 scale mapping. The map shows that there was an L-shaped building (or possibly two buildings) fronting Olney Road at this point, although it is uncertain whether it represents elements of the existing structure. Whilst, outbuildings are seemingly shown comprehensively throughout the map, there were no outbuildings to the rear of the property at this time.

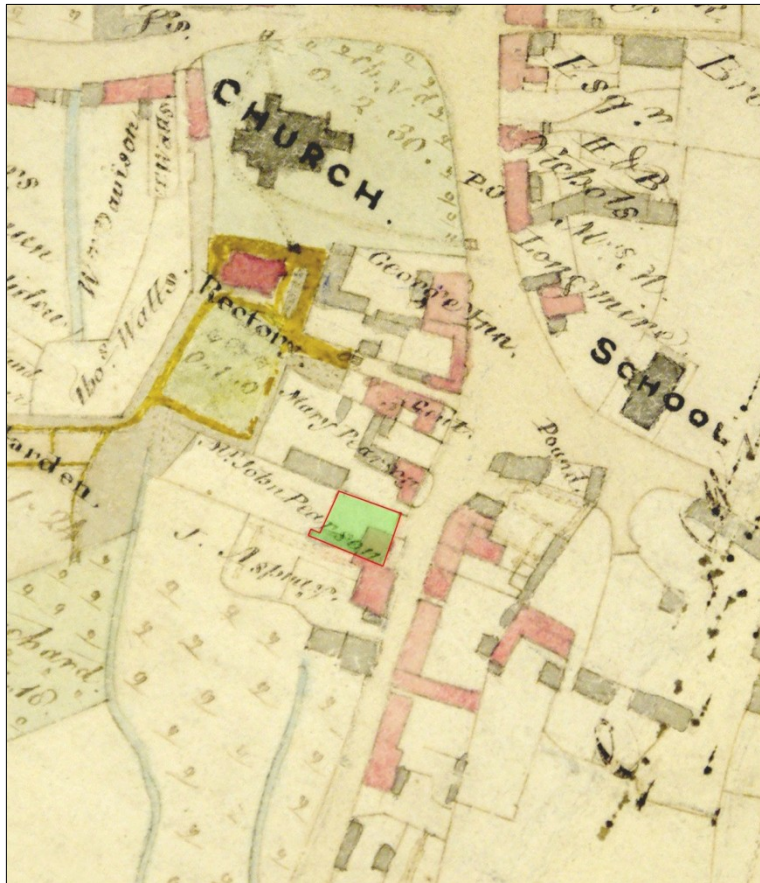
Figure.4

Extract of 1856 Plan of Lavendon by Isaac Lenny. Area of proposed development highlighted in green

- 5.18 A kitchen/scullery is located within a single storey range which is adjoined to the rear of the building alongside the SW property boundary (Fig.13, 8). A map of 1856 shows that a range of outbuildings was already present in this location (Fig.4) and it is quite possible that it is the same structure, but, if so, it is uncertain whether this was originally intended as a scullery. The floor is concreted. The room is accessed via a short passage from the backroom [39] and there is also a door in the NE corner opening to the backyard [44]. The ceiling is raised above the level of the wall plates and has white-painted tongue and groove panelling [42]. The room is lit by a 20<sup>th</sup> century metal-framed 6 pane window [44]. In the centre of the NW wall there is a chimney breast [42 and 43] – possibly where an in-built stove/ oven range was previously located. The hearth has been concealed behind metal panelling and alterations made to the breast to allow the insertion of a vent for a gas boiler. The present boiler probably dates to the late 20<sup>th</sup> century. To the left (SW) of the chimney breast there is a two-tier fitted wooden cupboard raised c.30cm above the floor [42 and 43]. Below the window there is an enamelled stoneware sink supported on two columns of bricks with attached metal alloy draining board [44]. This type sink was commonplace from the late 19<sup>th</sup> century through to the mid 20<sup>th</sup> century. A late 20<sup>th</sup> century free-standing gas oven is against the SE wall [45].

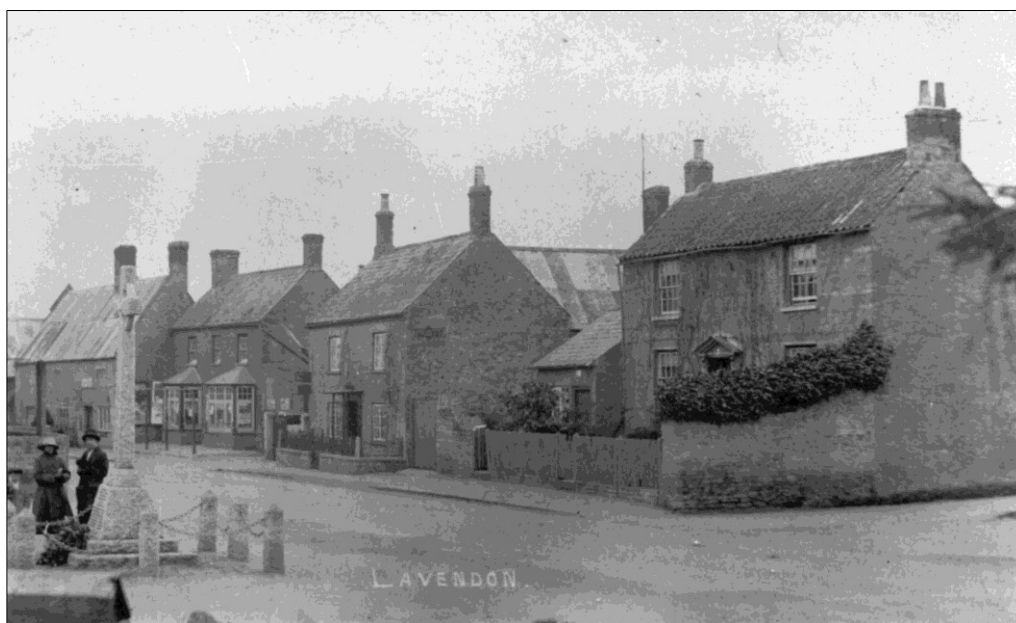
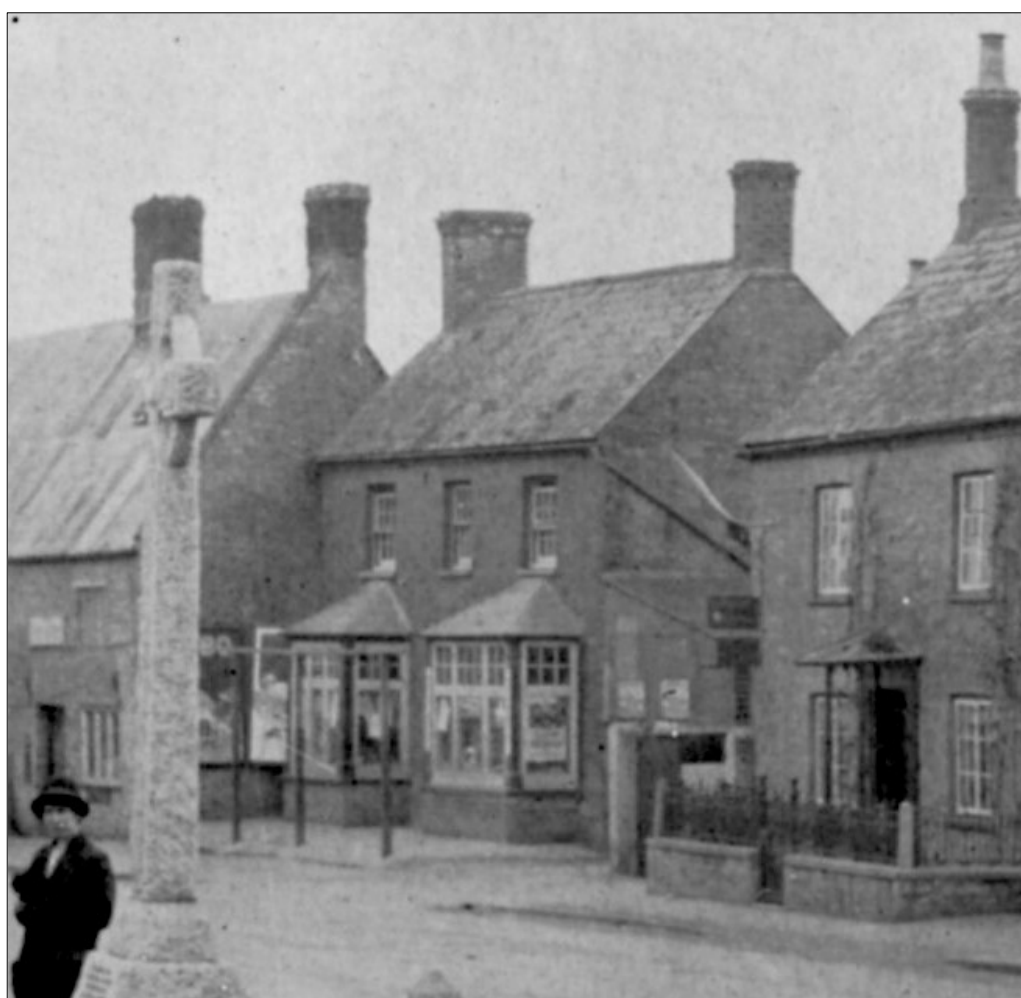
- 5.7 The SW side of the building is rendered in concrete (Fig. 19; [3 and 6]). The entire length of the SW elevation side seems to have previously abutted another stone building known as Glasscocks (*ante.* 4.10; Figs. 9 to 12), the latter which was demolished at some juncture between 1960 and 1978. In places where the render has fallen away it reveals stonework.

**Figure 10. Top: early 20<sup>th</sup> century view of No.8 Olney Road Lavendon, facing SW.  
Bottom: enlargement of photo ( Courtesy of Nigel Stickells, Lavendon Connection)**

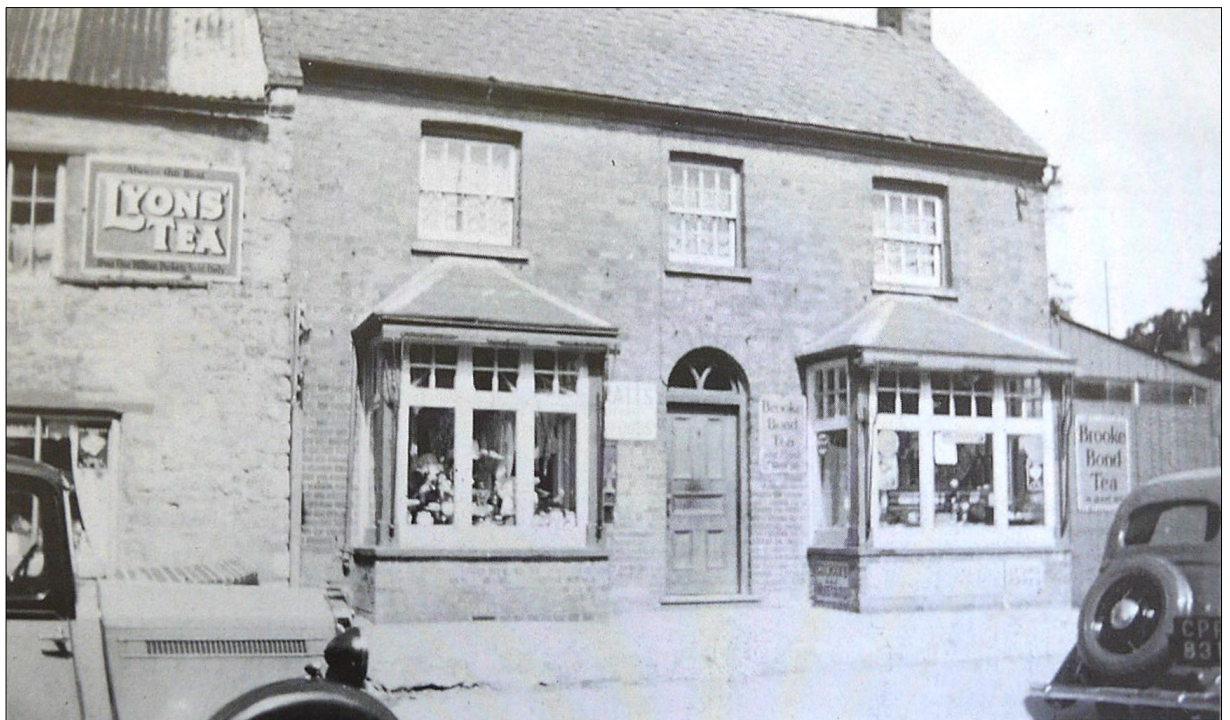
**Figure 12. Probably 'The Stores' of Mr & Mrs Cunningham c. 1930s, facing SW**

- 5.4 On either side of the entrance there is a three sectioned square bay window on a brick plinth c. 0.6m high (Fig.15) The brickwork of each plinth is rendered in concrete. The bay windows are slated and have lead flashing. The window frames are concealed by boards, though as they were visible inside the building they have been shown as un-boarded on the elevation drawing. A flat-roofed, glazed wooden front porch (1) was added, probably in the latter half of the 20<sup>th</sup> century, linking the two bays (Fig.13 and 15). The porch conceals the earlier front door with fanlight above (Fig. 12; [24, 27, 29]).

date to at least the early 20<sup>th</sup> century, and are thus likely to be original 19<sup>th</sup> century fixtures (c.f. Fig.12). Only the rising cast iron hinges of the door are likely to be original [28]. Just inside the door to the right, there is a short length of wooden wall panelling [17] to a height of c.1.7m, indicating that this was likely to have been the shop entrance side, with the entrance at the point where the panelling terminates.

- 5.23 The garage is in two sections [1], both of which are most likely to date from the latter half of the 20<sup>th</sup> century and may be compared to early to mid 20<sup>th</sup> century photographs (Figs.11 and 12). The front [2] is brick-built lean-to in stretcher bond, with corrugated steel roof and with a steel garage door. The rear section is wooden framed [46] with pitched roof covered in corrugated steel and weatherboard side cladding. It is lit from the NW (rear) by an 8 over 8 sash window [14] and from the SW side by a 6 over 6 fixed window [15]. A stone wall, 1.5m high, abuts almost the entire the length of the NE side of the garage (Figs 13 and 18).

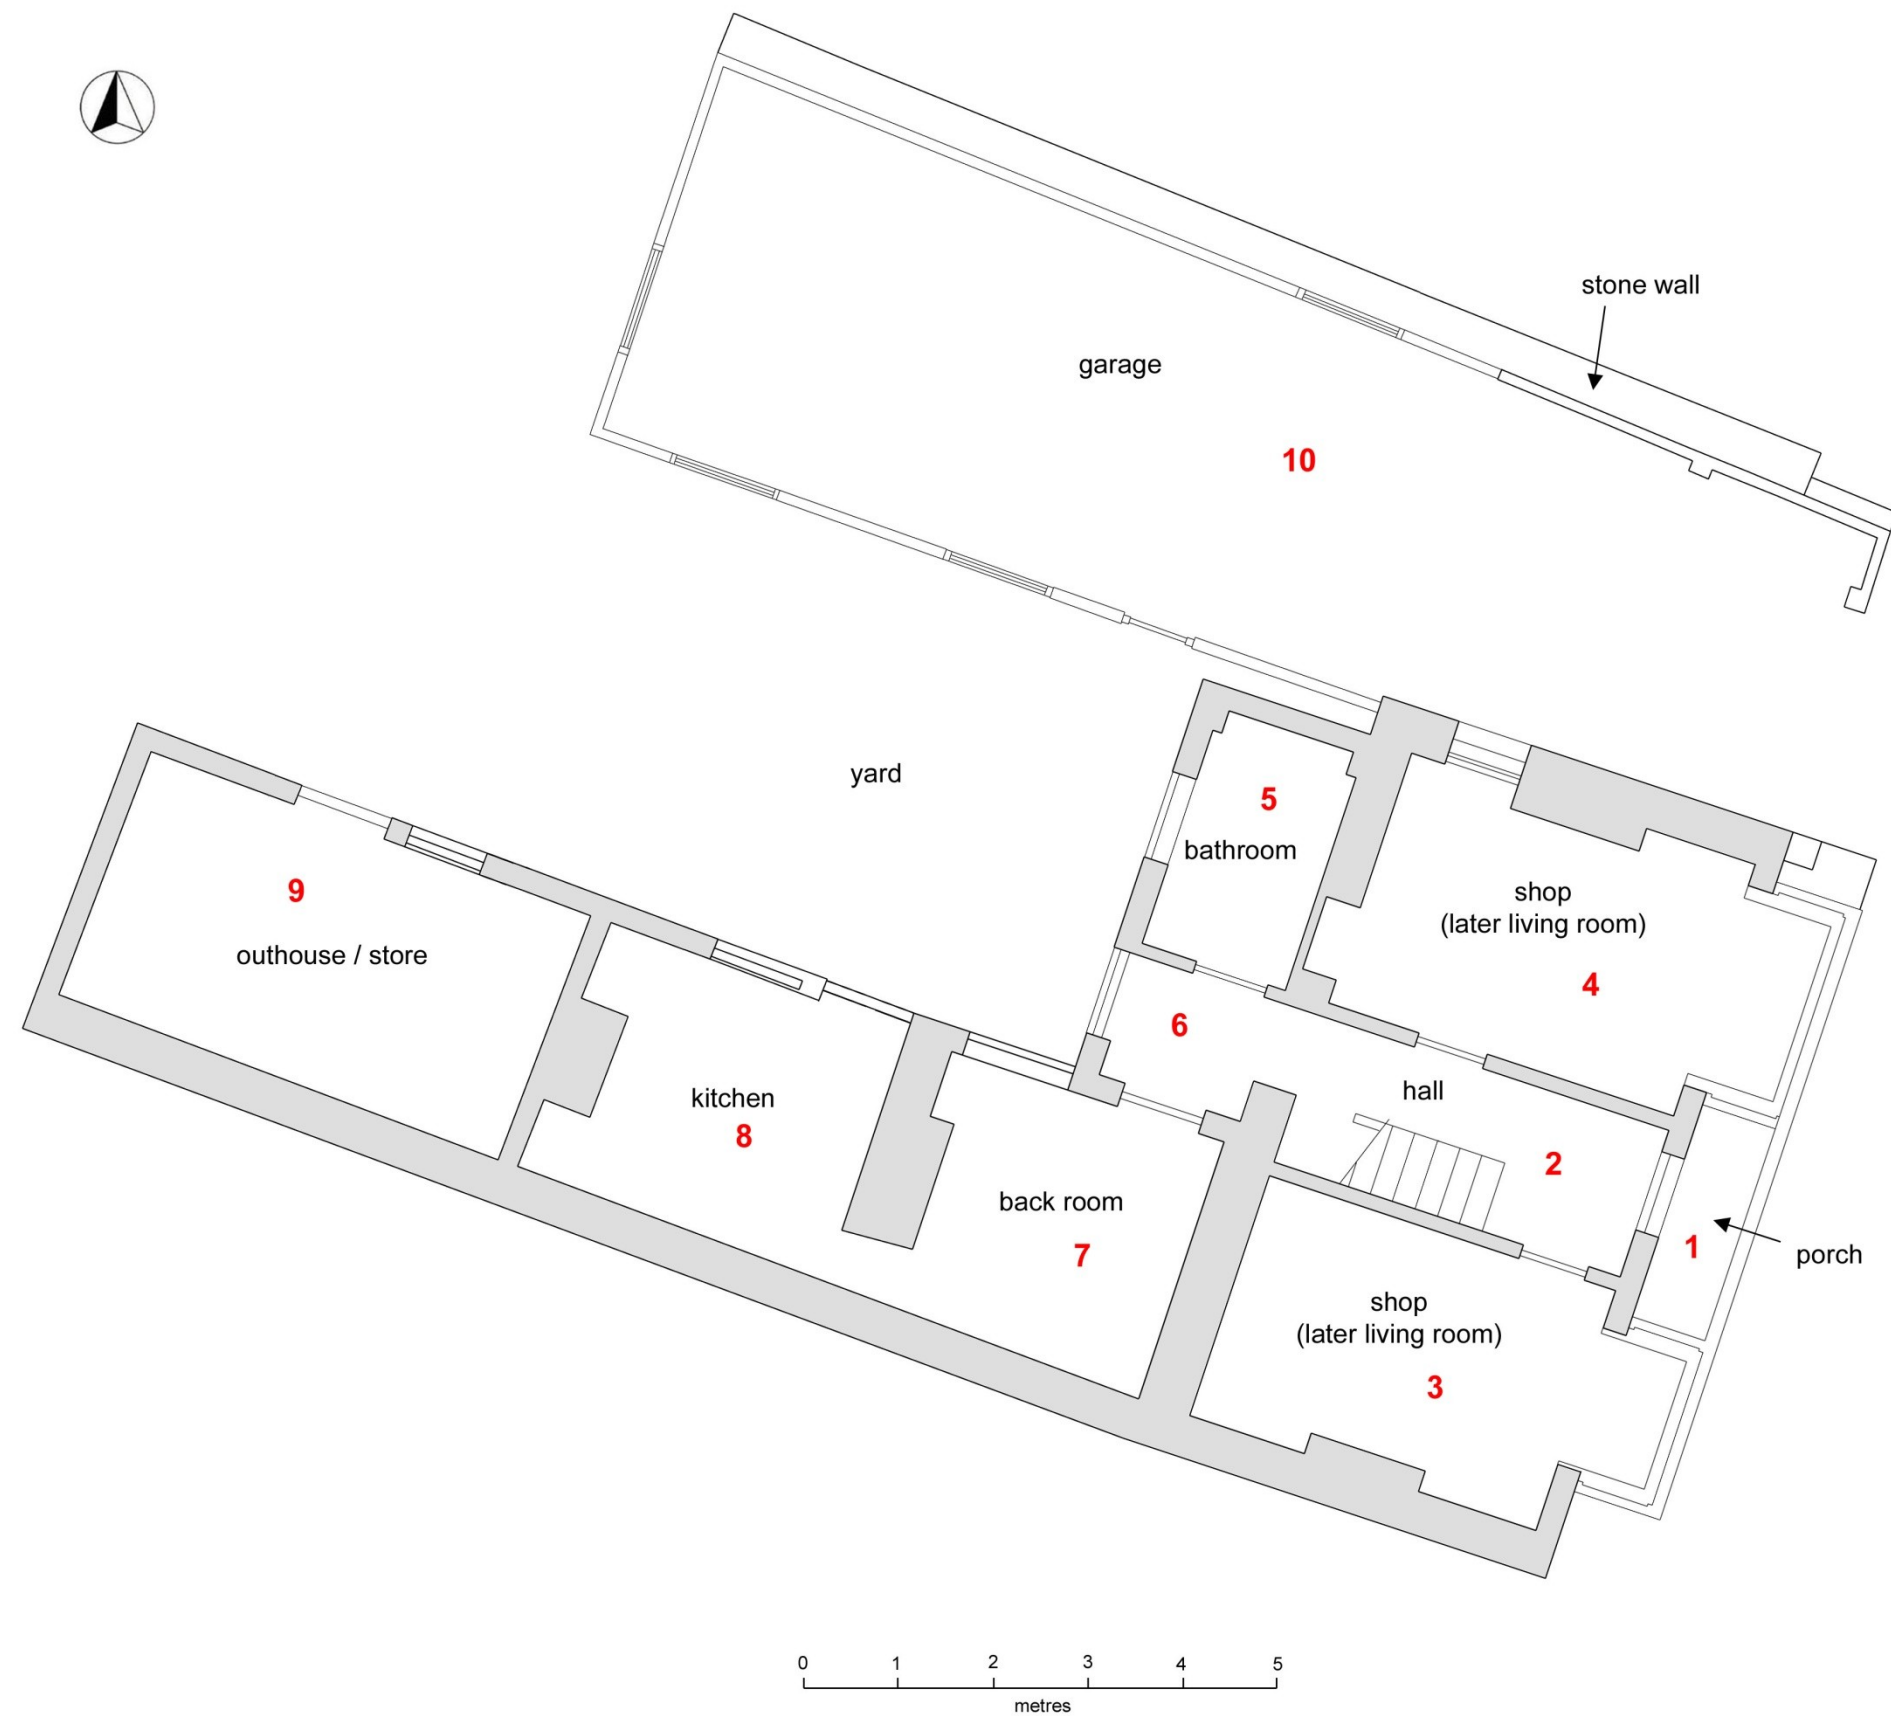
Figure 13. Ground floor plan

- 5.2 The property is composed of four general components:
- The original core house which was an L-shaped two storey brick and stone built structure with dual pitched roof (Fig.13, **1-4** and **7**; Fig.14, **11-13** and **15**);

- A single storey brick and stone-built range, or possibly two extensions on the same alignment, forming a kitchen and store/outhouse (Fig.13, **8** and **9**);

- A rear brick-built extension comprised of two storey brick-built link to the back rooms (Fig. 13, **6**; Fig. 14, **14**) and an adjoining single storey lean-to (Fig.13, **5**);

- A brick-built and wood-built garage (Fig. 13, **10**).

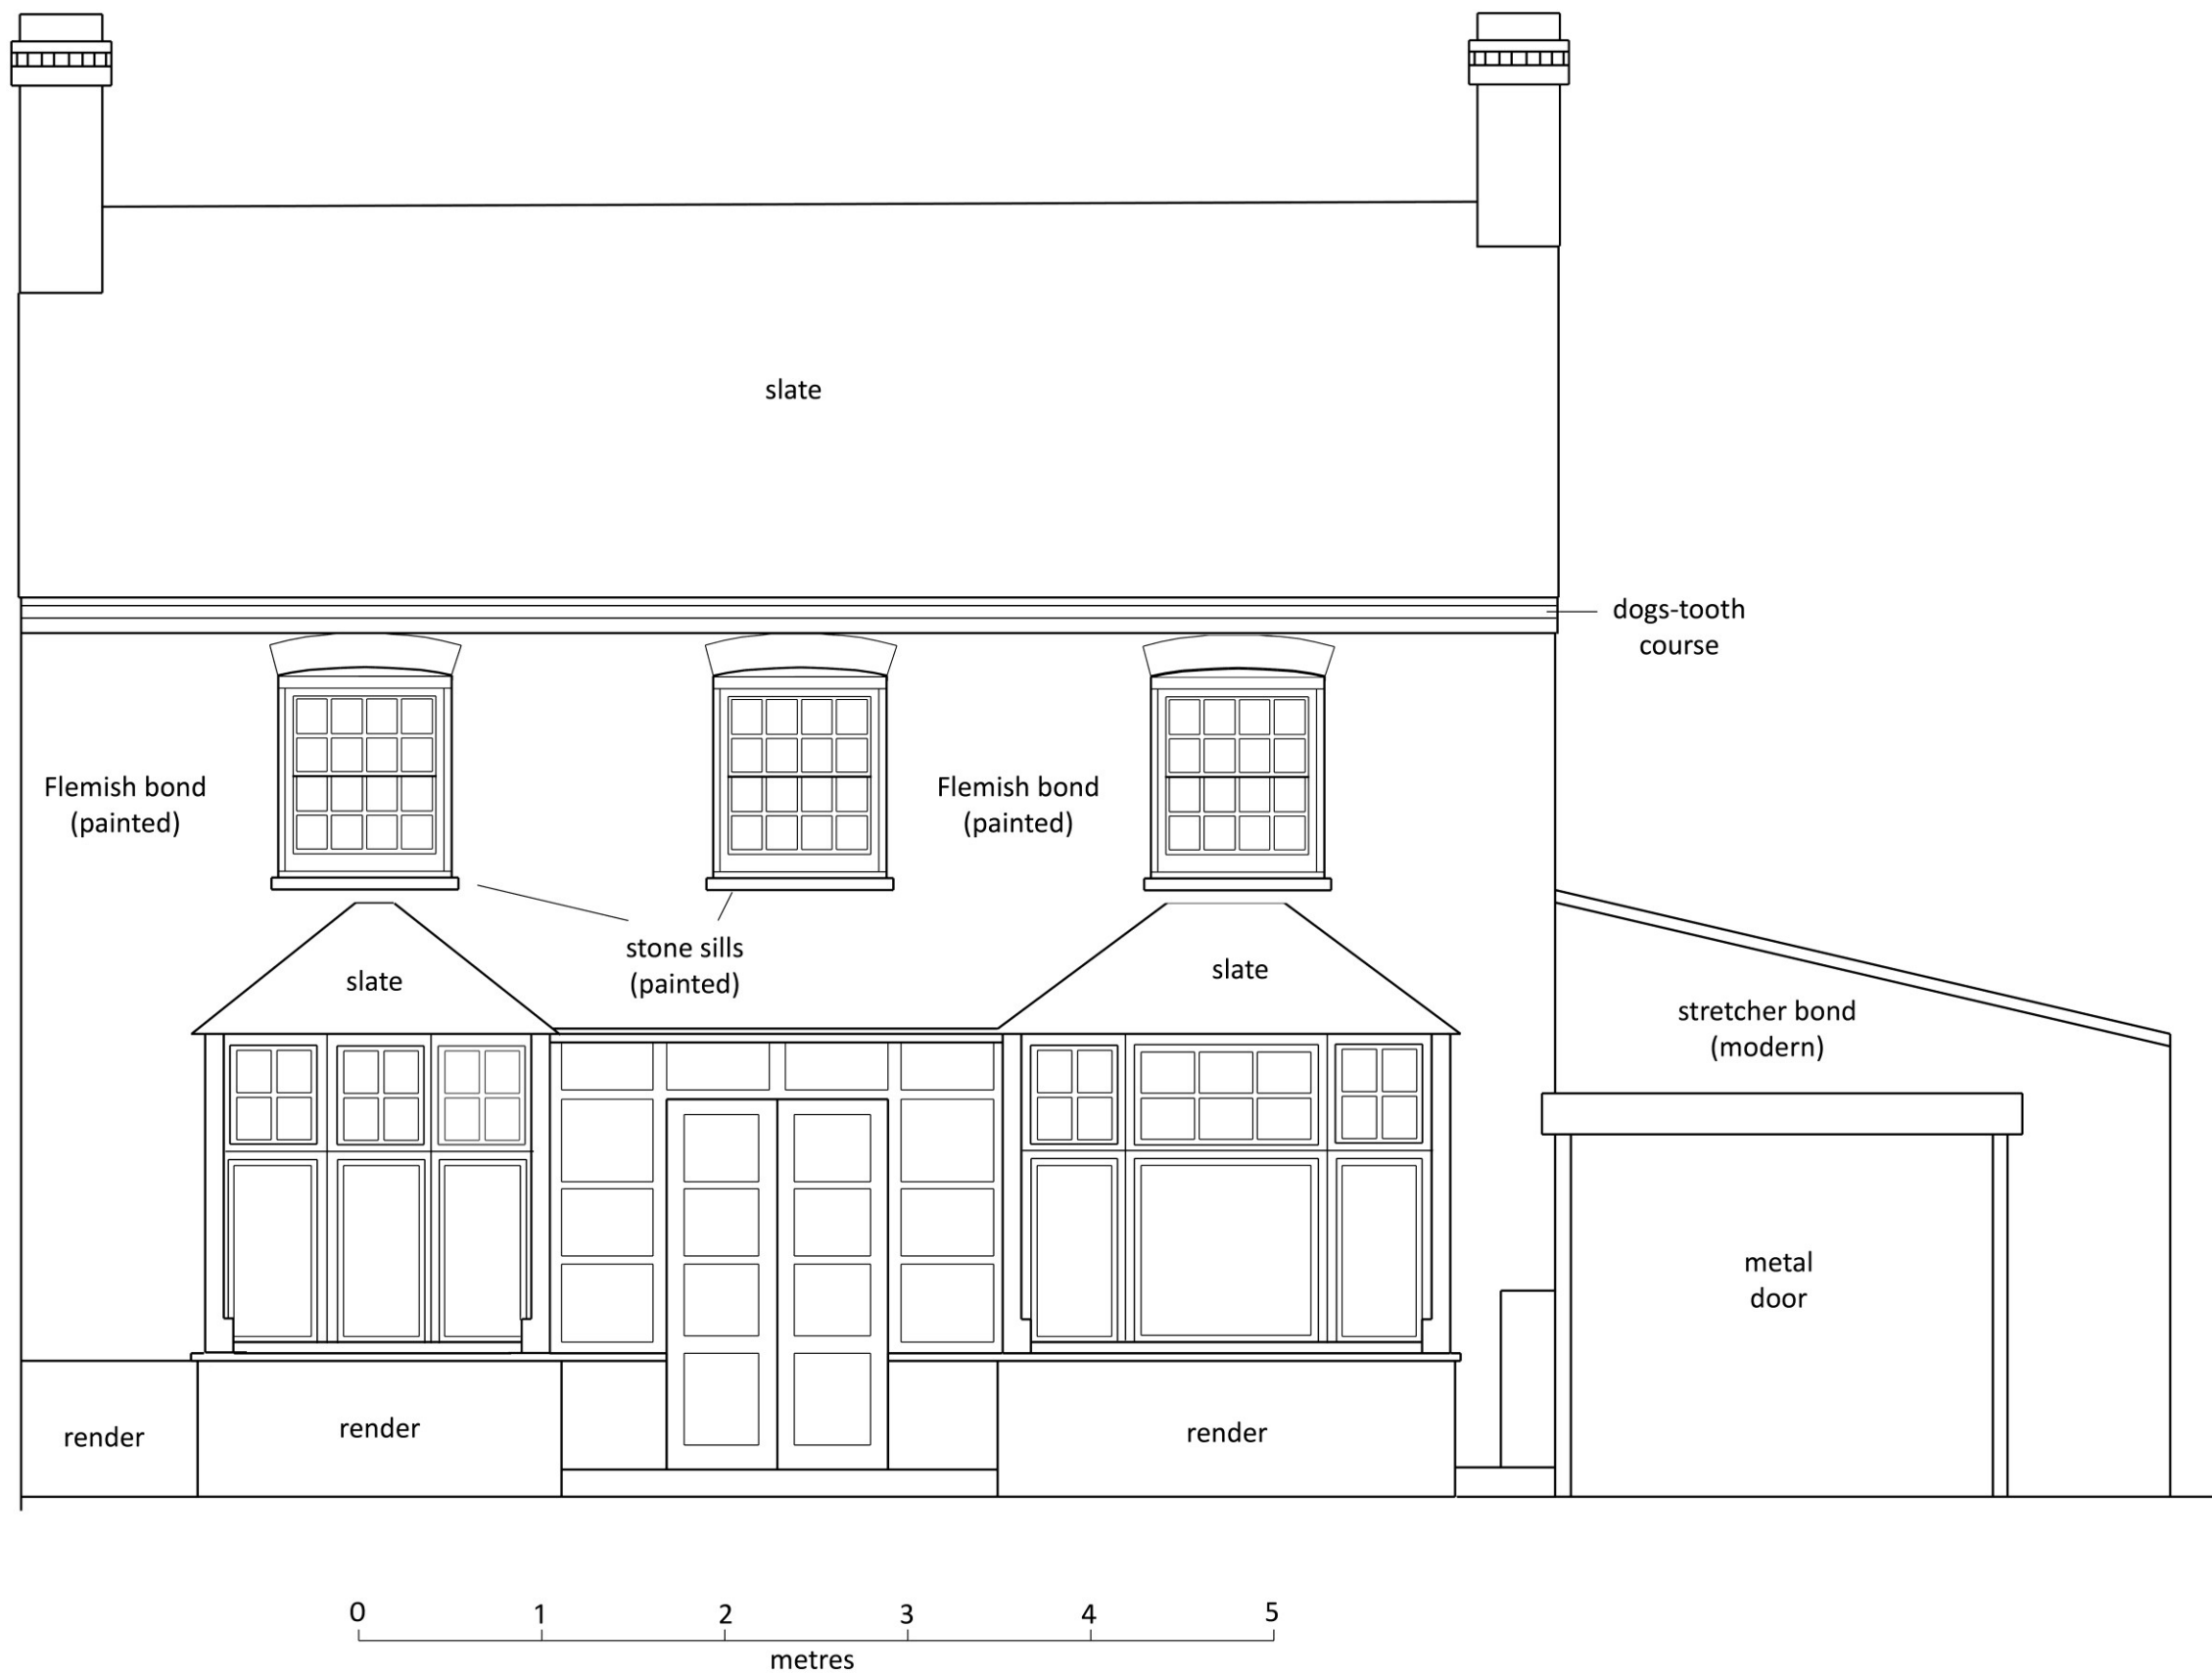
Figure 15 Front elevation (SE)

(Fig.15; [2]). The front of the house is constructed of brickwork in Flemish Bond, though heavily painted (and possibly lime-washed before that) [2 and 4]. Brick dimensions are: 8 ¾" x 2 ¾" x 4¼" (c.22 -22.5 x 6.5 x 11cm).

- 5.5 The first floor has three, equally-spaced sash windows with 8 over 8 panes, which are probably original (i.e. mid/late 19<sup>th</sup> century) (Fig.15; [2, 4]). Two of these windows light the front bedrooms, whilst the central window, which is slightly narrower, lights the landing. Each window frame is set under a shallow arch of single rowlock. The eaves have a course of dogs tooth. The roof is slated and there is a stack at each gable end. Each stack has a dog's tooth brickwork corbel. The stacks appear to have been rebuilt in the modern period.

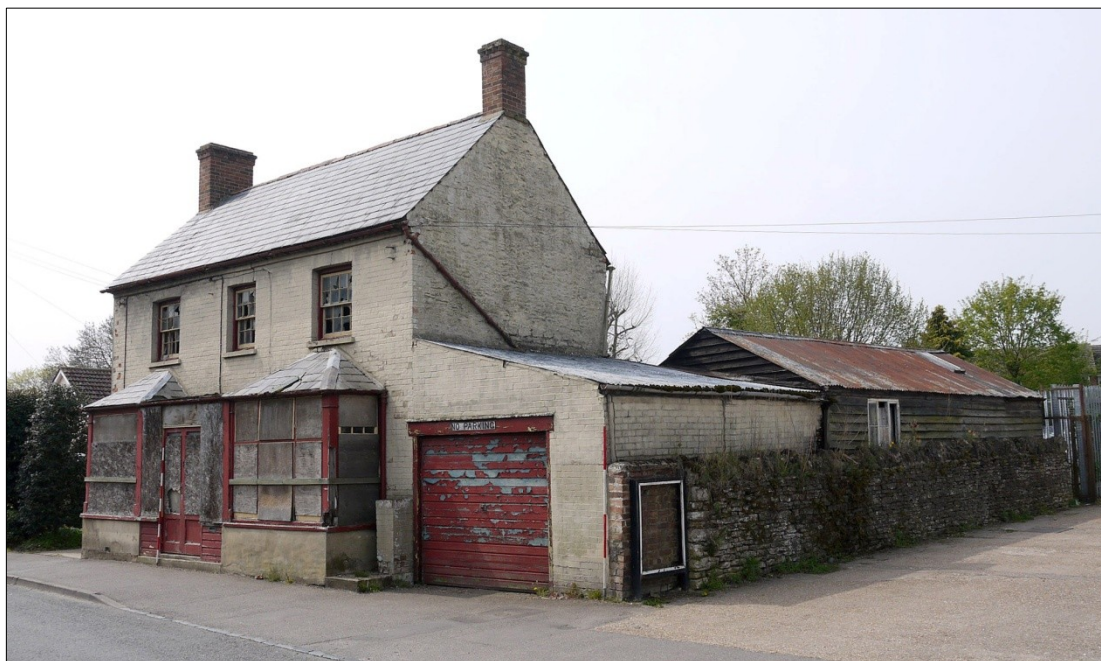
1

- 5.3 The building fronts the path alongside Olney Road, Lavendon [1 to 3]. Originally it was set back a few metres from the roadside (Figs. 4, 5, 9-12). The facade has apparent symmetry

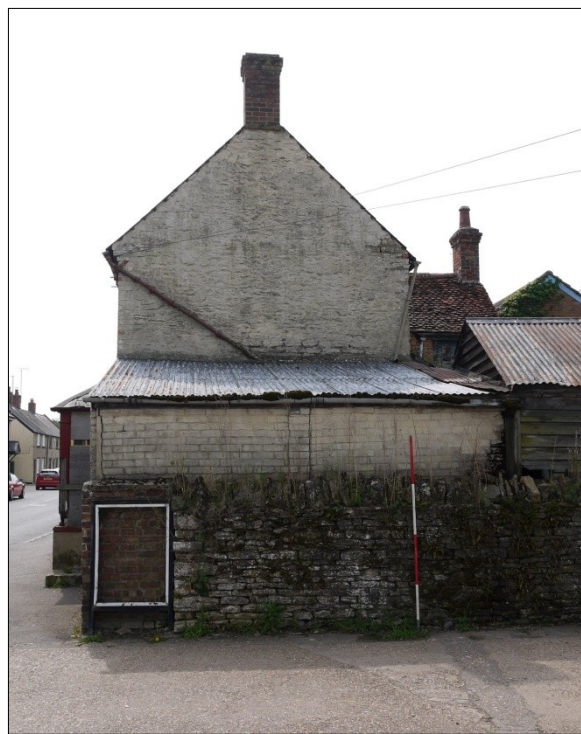
5

- 5.6 The NE wall is constructed of local limestone. The lower part is concealed inside the garage [9], whilst the upper part is lime-washed/ painted (Fig. 17; [5]).

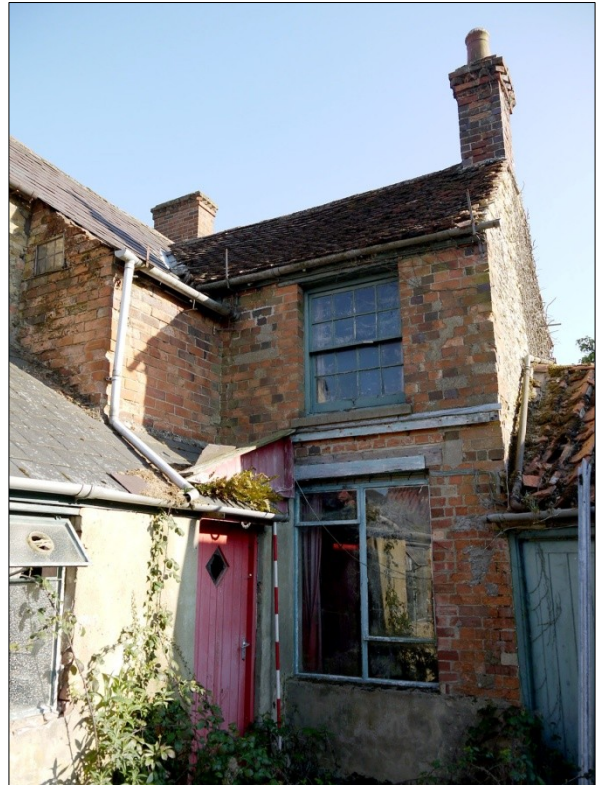
- 5.8 The rear part of the core house (i.e. the other side of the L-shape) is predominantly stone-built [7], with the exception of the NE elevation which is brick-built in English Bond (e b on Fig.16; [8]). The pitched roof has fish scale clay tiling [5, 6 and 8] and there is a stack at the gable end. The stack, with dogs tooth corbel, has been re-pointed though otherwise appears original. On the NE side, a large steel-framed casement window was inserted at ground floor level in the late 20<sup>th</sup> century (Fig.16; [8]), evidently in the location of a previous opening as indicated by a lintel scar in the brickwork above. On the first floor there is a 19<sup>th</sup> century wooden sash window with 8 over 8 panes (Fig.16; [8]).

- 5.9 In the rear angle of the L-shape there is a single and two storey brick-built extension (Fig.13, 5 and 6; Fig.14, 14; Fig.18; [7-8]). This appears to have been built in a single event. The single storey part of the extension is a lean-to, housing a bathroom (5) (*post.* 5.17), while the two-storey part provides a rear lobby at ground level with access to the back room (7), and a landing-link at first floor level to the rear bedroom (15). Both elements of this extension are in stretcher bond (SB on Fig.16; Fig.18), the lean-to having been concrete rendered. Notably, the brickwork of the two-storey element incongruously abuts both the rear elevation (NW) of the core house and the English Bond brickwork of the NE elevation of the rear part of the house. The slated roof of the two storey extension is continuous with the roof of the core house, indicating that the roof was slated in a single event, and probably a re-covering event.
