Archaeological Investigation:
No.8 Olney Road, Lavendon
Olney MK46 4EU
(NGR 491625, 253553)

Planning Application Ref. 14/00093/FUL

Milton Keynes HER Event No. EMK1282

SOUTERRAIN PROJECT SOU15-397

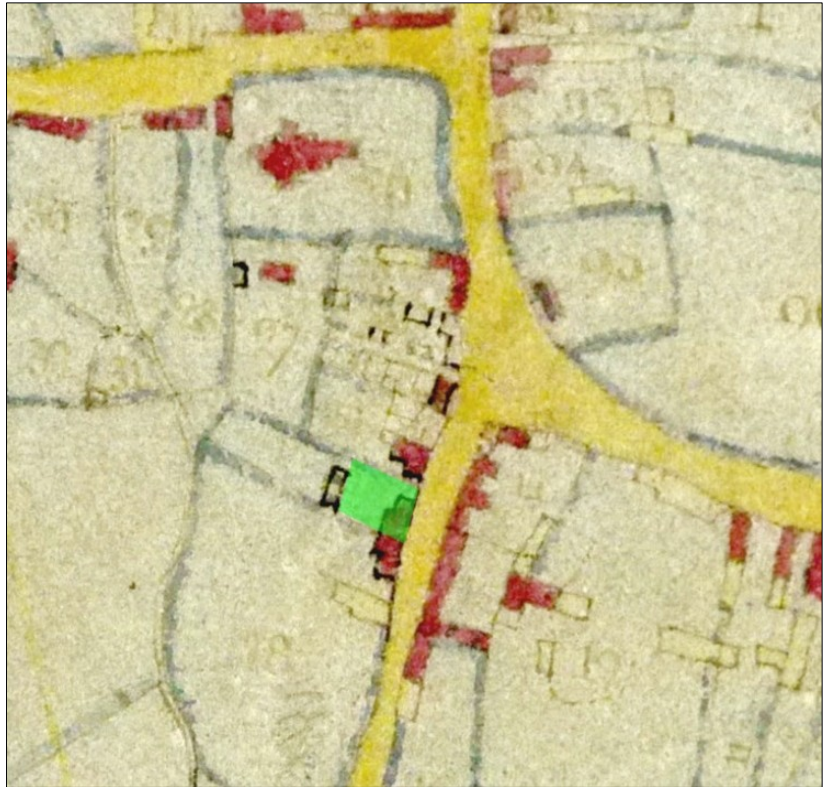
Figure 3

Extract of 1856 Plan of
Lavendon by Isaac Lenny

Area of development
highlighted in green

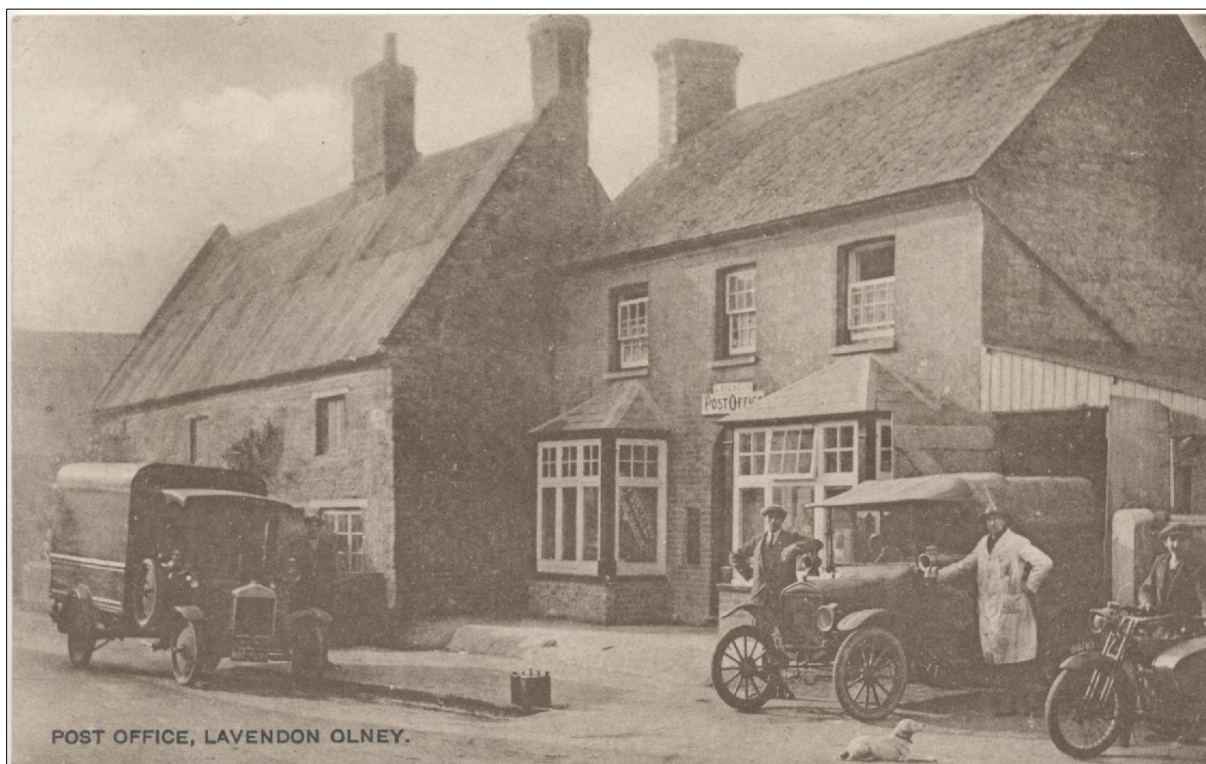
Figure 6. Early 20th century view of the lavendon Post Office at No.8 Olney Road Lavendon, facing SW
(Courtesy of Nigel Stickells, Lavendon Connection)

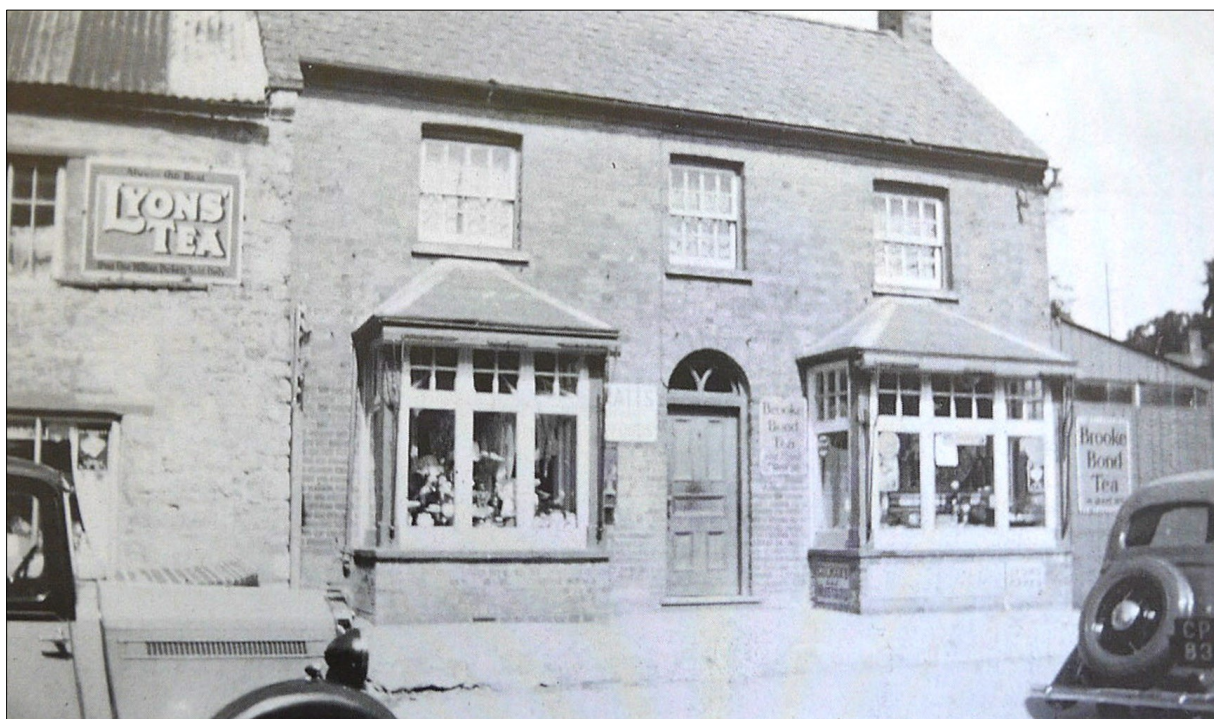
Figure 7. 'The Stores' of Mr & Mrs Cunningham c. 1930s, facing SW
(Courtesy of Elizabeth Knight, Olney. Photo of T Whinnet)

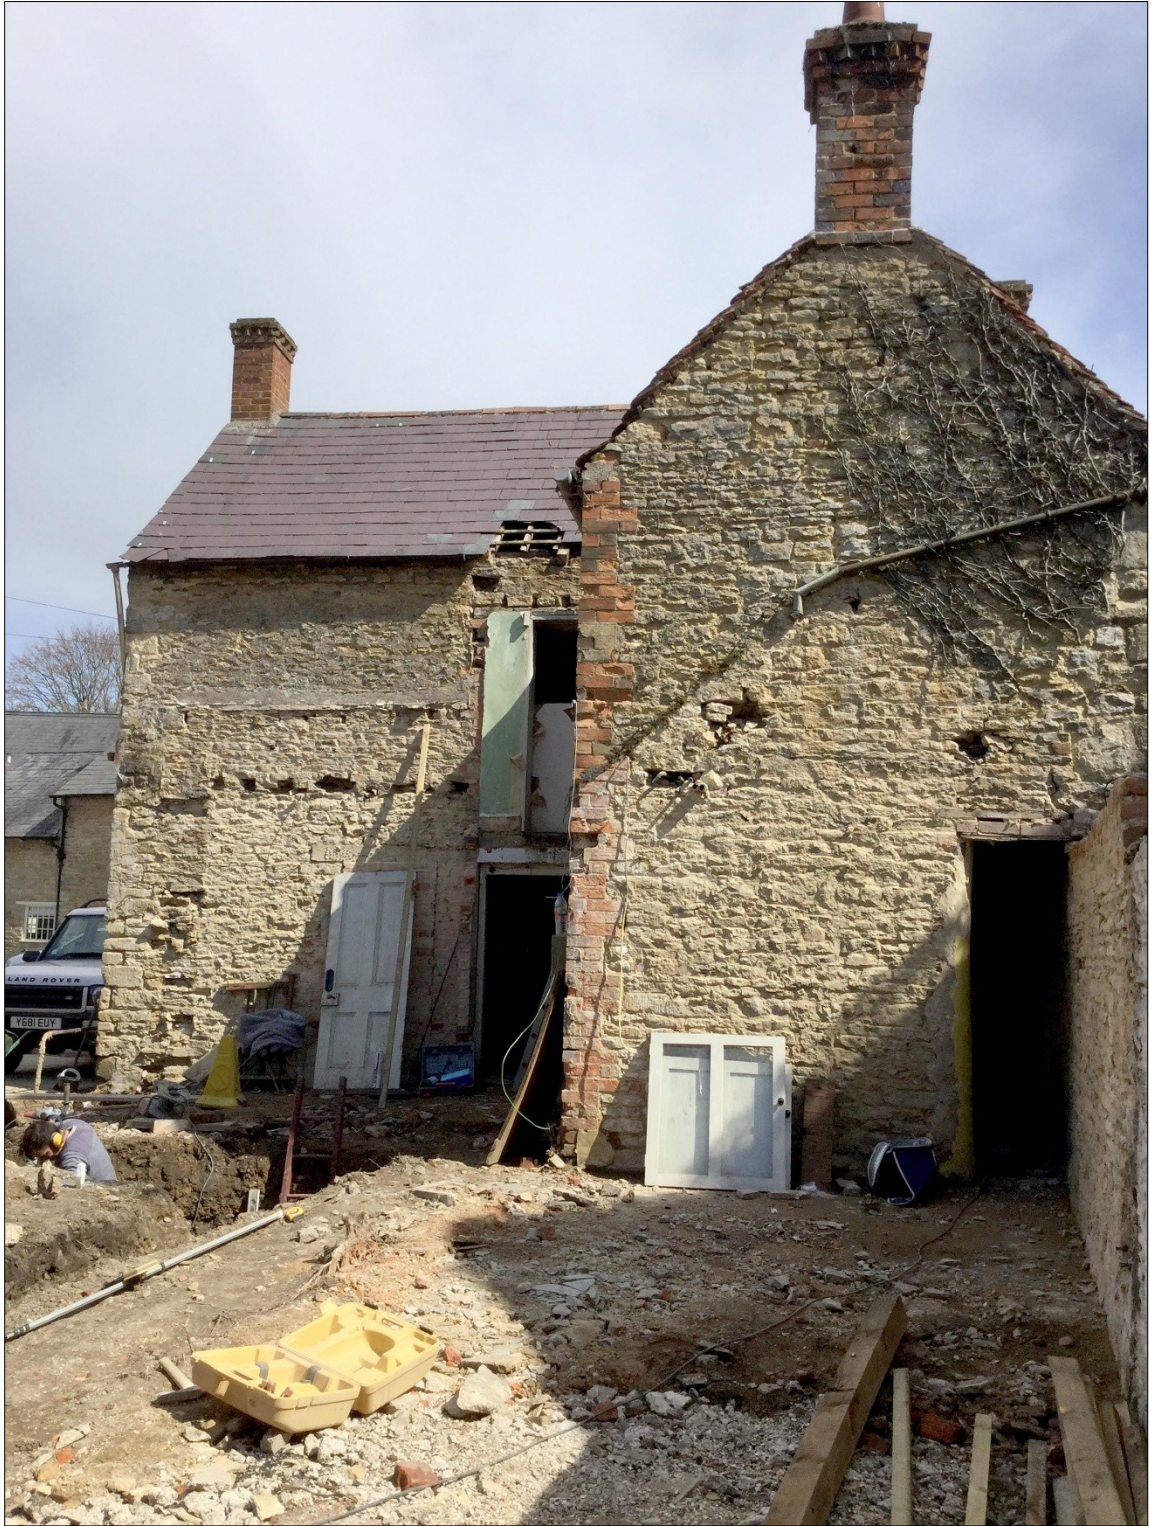
1

- 6.4 At the time of the Historic Building Record in 2015, the rear lower half of the original L-shaped house had been largely obscured by a large 20th century wooden garage and a brick-built single storey rear extension. The removal of these additions allowed the opportunity to photograph the rear of the building prior to the construction of the new extension [1 - 2].

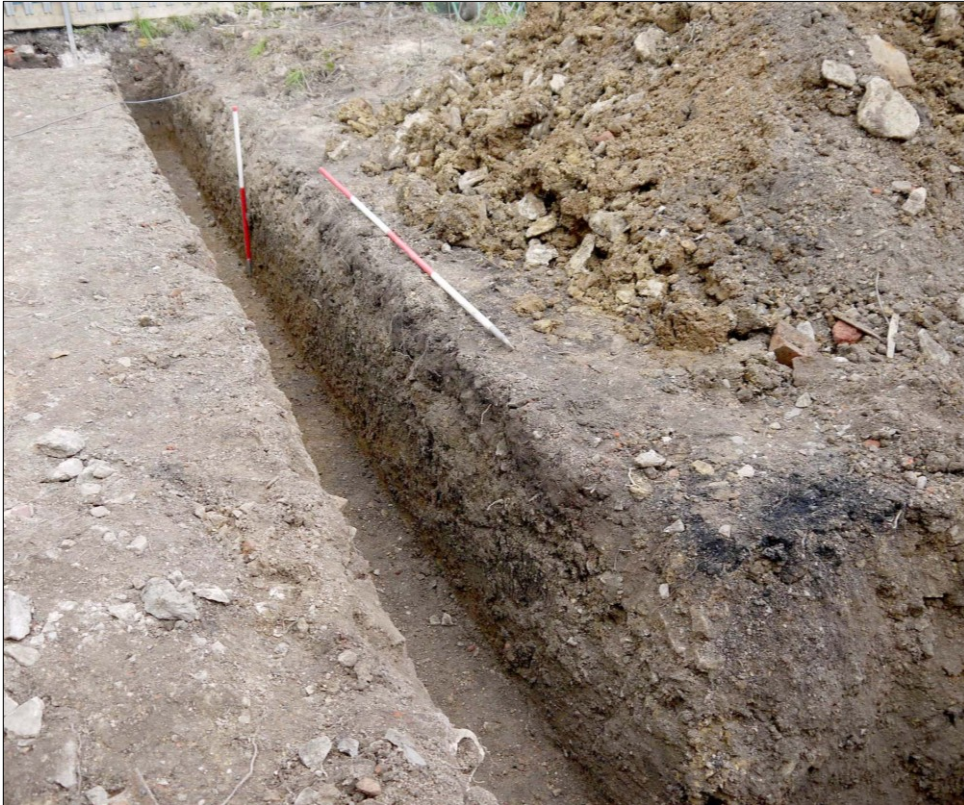
5

- 6.2 In proximity to the rear of the house was a stone-lined well (003) (Fig. 8, [5 – 7]). The well was located c. 0.25 m below the present ground surface. The stones of the well were un-mortared. Its internal diameter was c. 0.43 m, increasing to c. 0.5 m at a depth of c. 1.3 m. It was exposed to a depth of c. 1.5 m, at which point the present water table was reached. It was not possible to determine if the well had been cut into the made-up ground (001) or if the latter had been deposited around the structure. It is likely that the well was contemporary with the house. It had been back-filled with pieces of scrap iron, amongst which was a 20th century screw-topped glass pickles-type jar. The property's last occupant, Frances Horwood, had previously informed the building's present owner that an old well had been in-filled somewhere in the back yard.

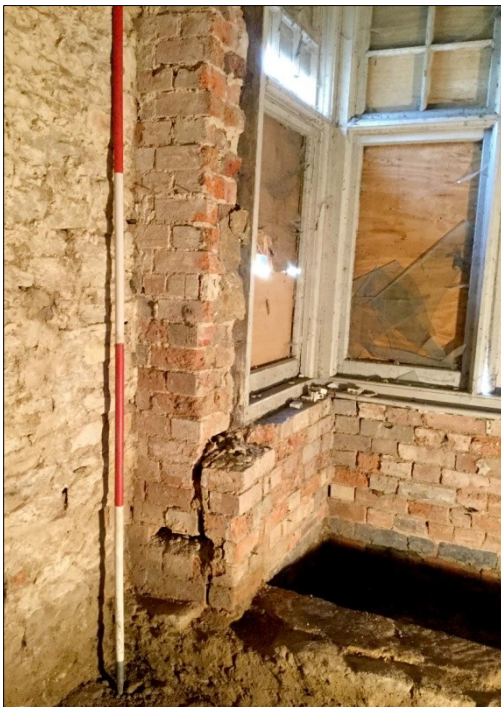
- 6.7 The groundwork partially exposed a plinth wall foundation of stone (005) upon which the house walls stand, including the internal walls (Fig. 8). The plinth wall was c. 0.28 - 0.3m wide and stood to height of c. 0.26 m. Notably, a SE section of the plinth wall separated the room from its bay window area, with indications that it represented the former course of the front wall of the house. Chopped out brickwork above the plinth wall on either side of the bay [9 and 10], showed that the bay was a later addition.

PROJECT: No. 8 Olney Road, Lavendon, Buckinghamshire Watching Brief			
For direction of photographs refer to report Figures 8 to 10			
No. (in report)	Direction (facing)	Description	Date
1	SE	House, rear, after demolition of 20 th century garage and rear extension	27.04.2106
2	S	House, rear, after demolition of 20 th century garage and rear extension	19.05.2016
3	SW	Area of new extension, pre-excavation, rear 19 th century outbuildings part-demolished	27.04.2106
4	NW	Foundation trench for new extension	27.04.2106
5	SW	Stone-lined well in rear yard	27.04.2106
6	SW	Stone-lined well in rear yard	27.04.2106
7	SE	Overview: location of of brick-lined well (left) and stone-lined well (right, by ranging pole)	27.04.2106
8	E	Ground floor, NE room, part-removal of floor make-up showing stone foundation walls	09.05.2016
9	E	Ground floor, NE room, break in front wall) brickwork (NE side) where bay was inserted	09.05.2016

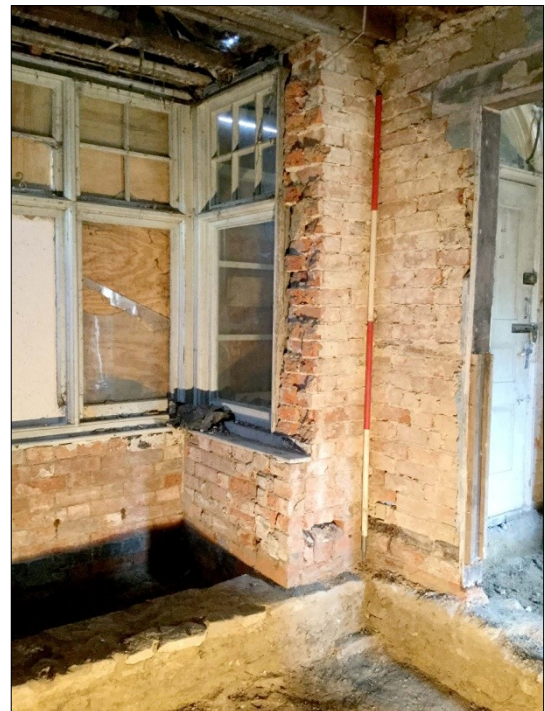
10	SE	Ground floor, NE room, break in front wall) brickwork (SW side) where bay was inserted	09.05.2016
11	SE	Ground floor, SW room, part-removal of floor make-up showing stone foundation wall	09.05.2016
12	E	Ground floor, SW room, foundation of bay window	09.05.2016
13	SW	First floor, NE room, view of battened walls after removal of plaster and lath	19.05.2016
14	NW	First floor, SW room, view of battened walls after removal of plaster and lath	19.05.2016
15	SW	First floor, stair well, view of battened walls after removal of plaster and lath	19.05.2016
16	SW	First floor, wooden lintel above rear window above stair, salvaged timber medieval/post-medieval building with stave holes	19.05.2016
17	SE	First floor, NE room, view of ceiling joists after removal of plaster and lath	09.05.2016
18	NW	First floor, SW room, view of ceiling joists after removal of plaster and lath	09.05.2016
19	-	Birth certificate of Kathleen Joan Warner, 30.06.1915, recovered from wall safe	27.04.2106

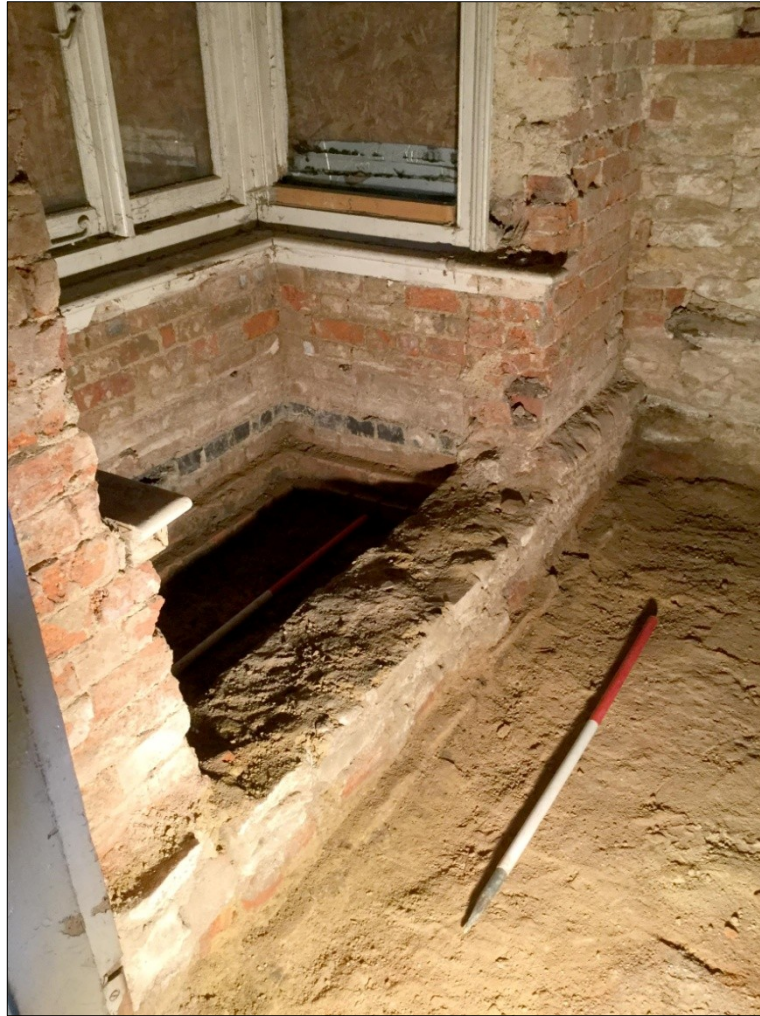
11

- 6.8 The removal of a boarded floor in the SW room revealed a floor make-up of hard and compact fine rubble (007), which was also excavated to the required construction depth of c. 0.15m - 0.2 m [11]. A single sherd of medieval pottery was found in the make-up (*post.* 7.1, Table 1). As with the NE room, the groundwork partly exposed the plinth foundation walls (005) of the house and, similarly, revealed a wall separating the SE room from its bay window area (Fig. 8). Again, the brick wall which had stood on top of the plinth wall had been crudely chopped out to insert the bay window [11]. The brick foundations of the bay window were exposed. It comprised three courses of well-faced brick, each with a shallow rectangular frog [12], above which was a string course of engineering brick. The remainder of the bay was built of poorer faced brick, possibly reclaimed material to match the existing building.

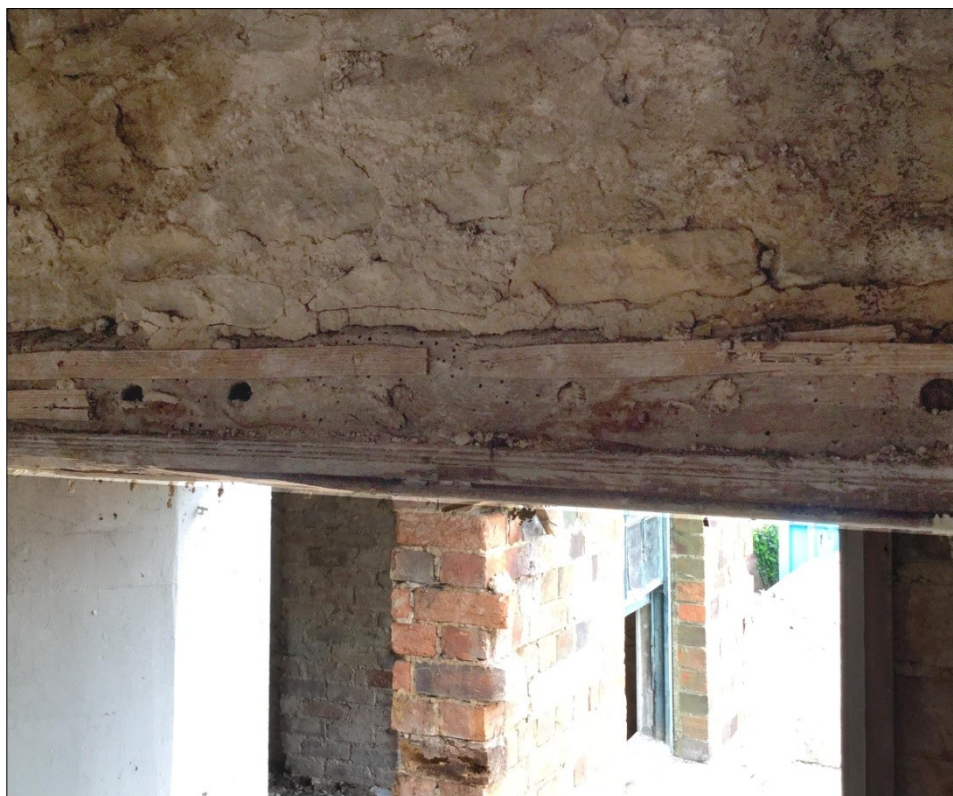
16

- 6.13 A lintel of a rear window above the stair has stave holes (for wattle and daub) [16], and was evidently salvaged from a medieval or post-medieval timber-framed structure.

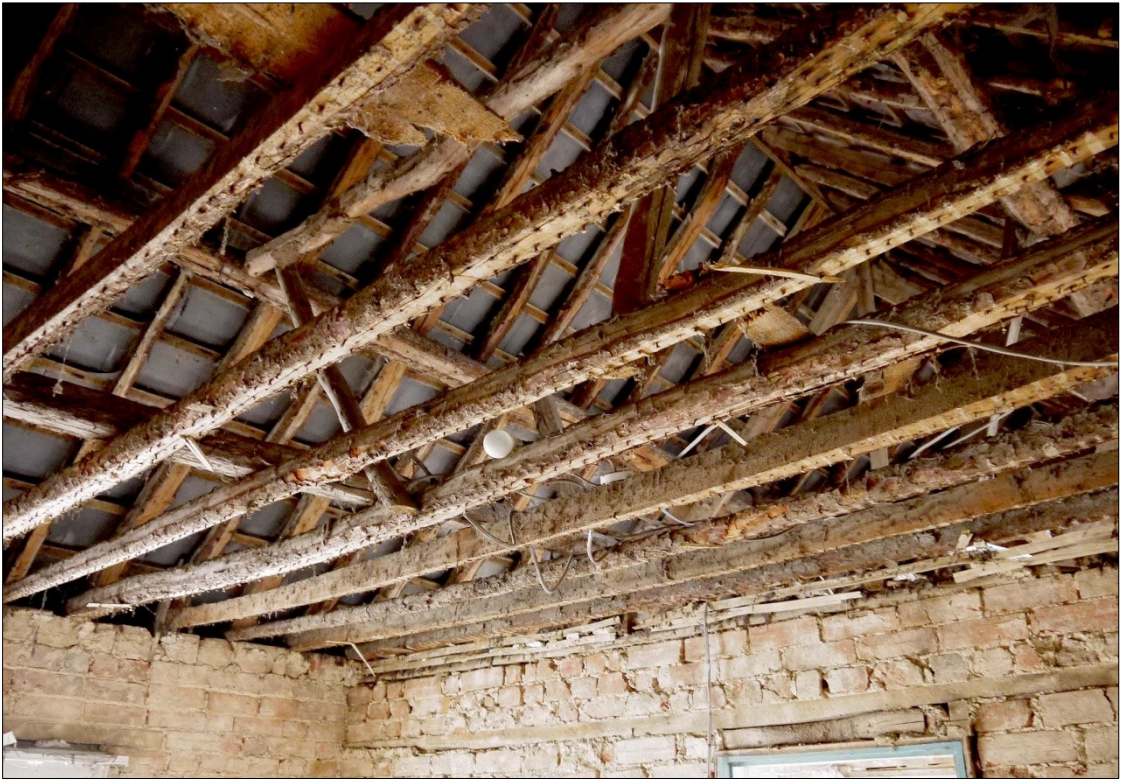
17

- 6.12 Although during the previous historic building record views of the roof space had been restricted, it had been observed that all visible elements of the roof frame (purlins, tie beams, props and rafters) were crudely carpentered. The removal of lath and plaster from the ceilings prior to the watching brief revealed that the floor joists and other elements of the roof frame were constructed of waney edge timber [17-18], many pieces of which still retain bark.
